# Manhole Inspection Summary

Manhole # S06EE2009MH

Insp Date: **9/25/06 4:09 PM**

**Location** Address: **7025 WALLIS AVE**

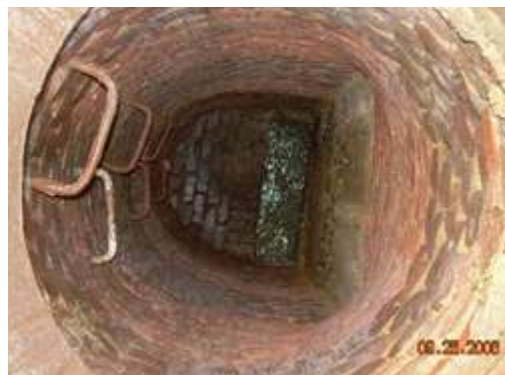
Top View

Frame leaks. Adjustment and Barrel infiltration. Evidence of surcharge - Bench debris. Corroded steps.

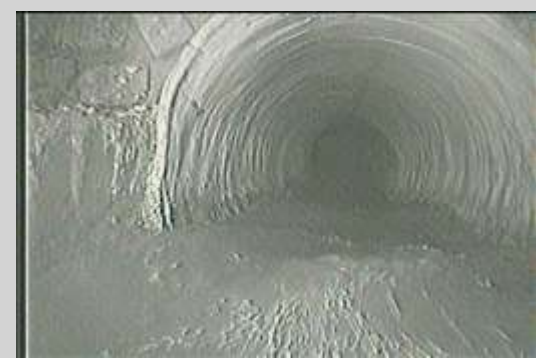
### 18 in. Circular Gravity Sewer Pipe Out @ 12 O'Clock

Pipe Material: **Unknown** ☒ Pipe Lined

Invert Depth: **13.90** (ft.) Flow Characteristics: **Fast**

Infiltration: **None** Pipe Seal Cond: **Unknown**

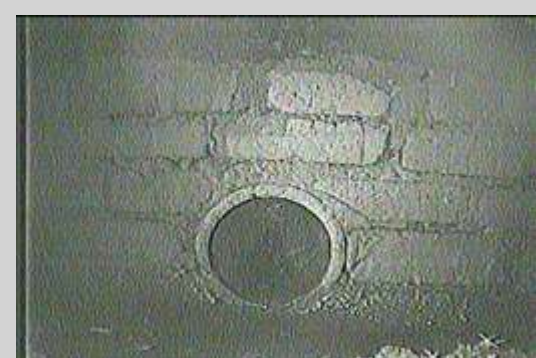
### 6 in. Circular Gravity Sewer Pipe In @ 3 O'Clock

Barrel deterioration and infiltration.

Infiltration: **None** Pipe Seal Cond: **Cracked**

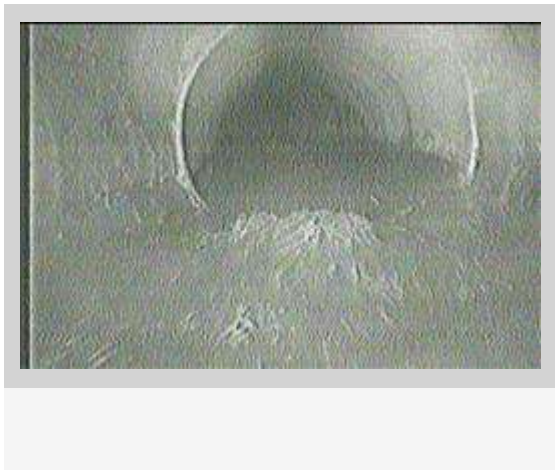
18 in. Circular Gravity Sewer  
Pipe In @ 6 O'Clock

Pipe Material: **Unknown** ☒ Pipe Lined

Invert Depth: **13.87** (ft.) Flow Characteristics: **Fast**

Infiltration: **None** Pipe Seal Cond: **Unknown**
